EB CURING OF VARTM FABRICATED MARITIME COMPOSITE STRUCTURES

Contract USZA22-97-P-0013
CDRL A002

September 19, 1997

DAMILIC Corporation
14670 Southlawn Lane
Rockville, MD 2085

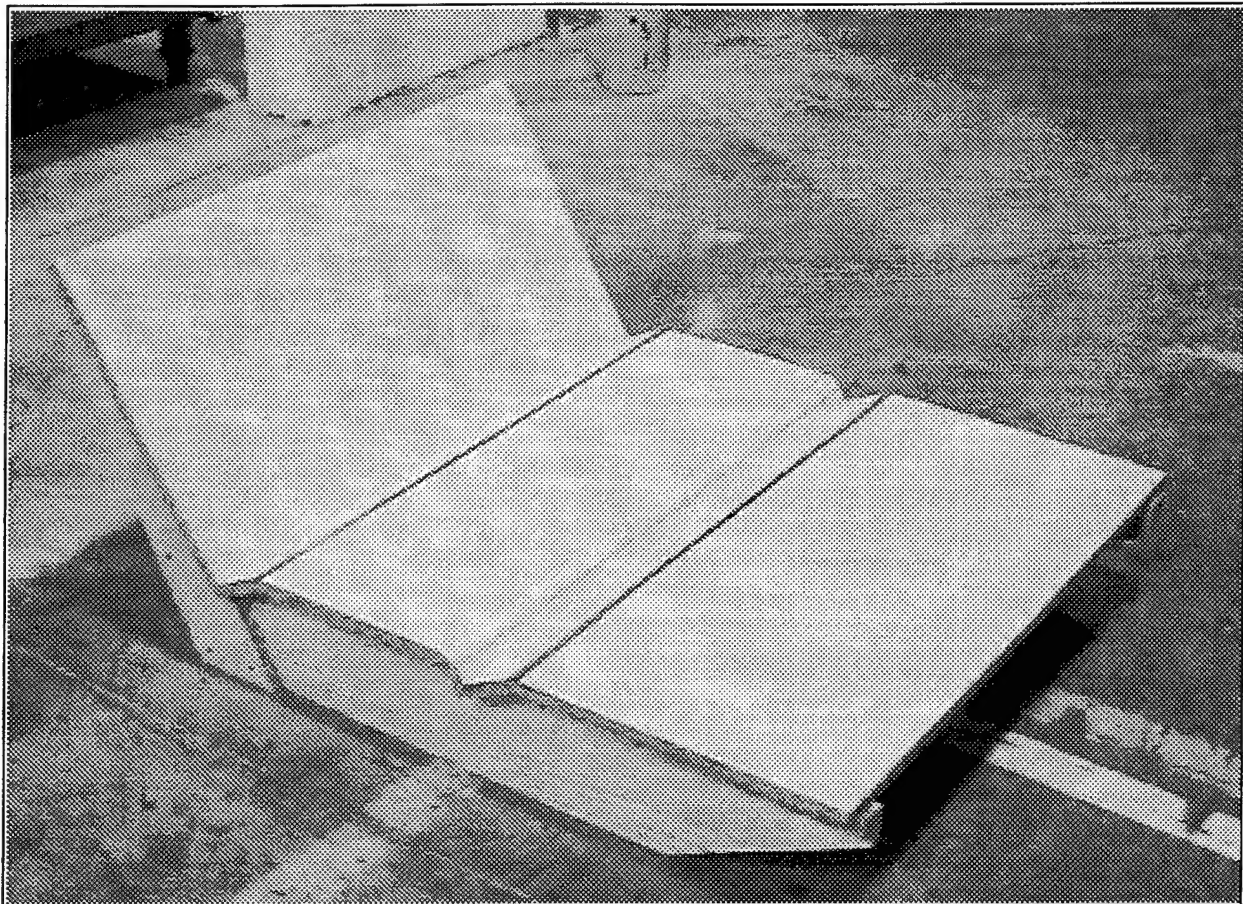
Because EB cures can be achieved at room temperature, no special consideration for high temperature operation was included in the tool design and construction. Unfortunately, the elevated temperature (ref. Figure 7), resulting from exothermic reaction during cure, exceeded the rated operating temperature of the epoxy fillet. This resulted in loss of vacuum during the EB cure, exacerbating the part's delaminations, and some local contamination of the hull outer surface with epoxy. This particular tool will require some minor rework for additional use. However, the use of a more appropriate epoxy would render this tool reusable for many production runs.

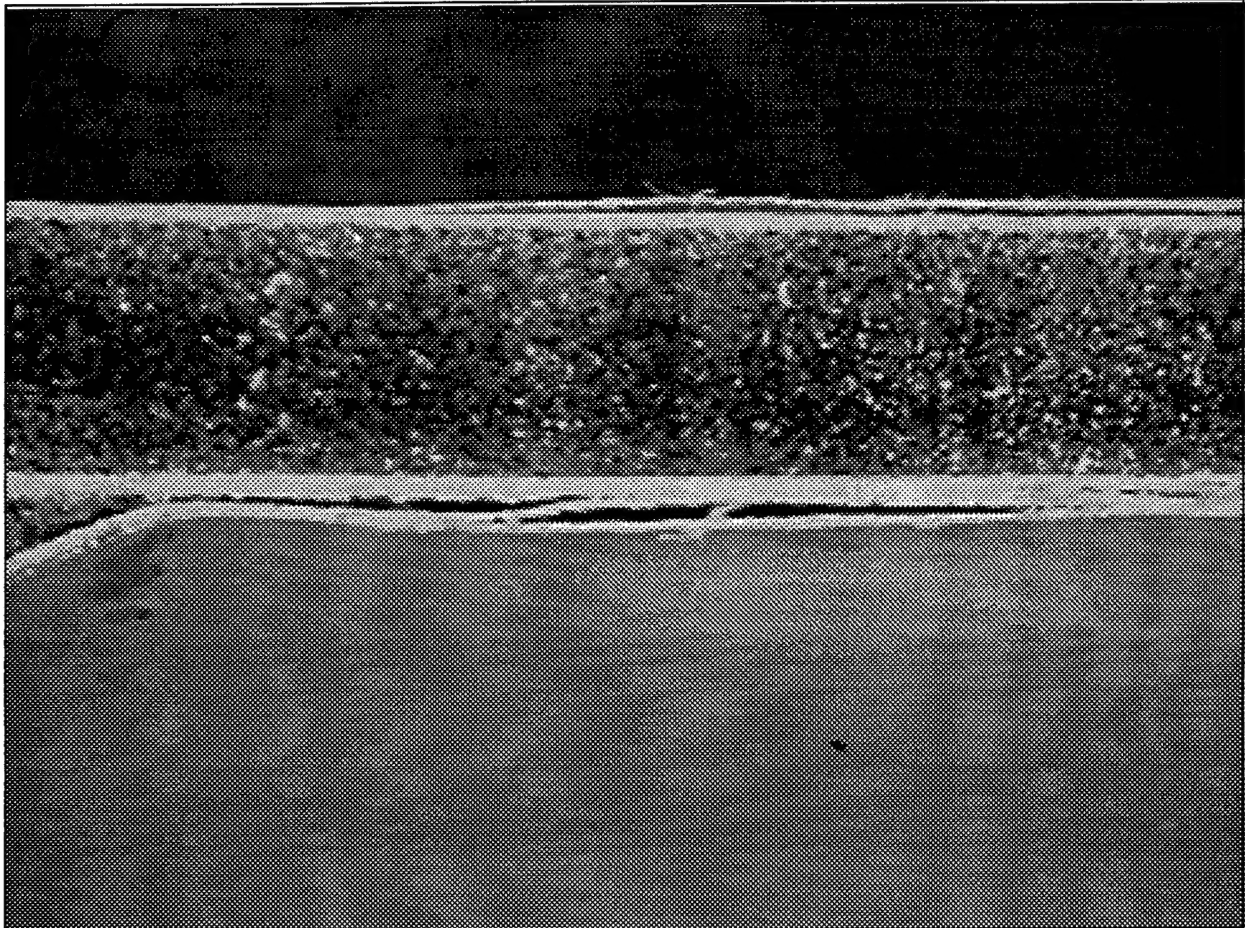
- 1) An elliptical area approximately 5" x 10" between the individual Kevlar fabric layers on the inside surface of the hull (i.e. the side with the longitudinal support structure) was observed immediately after removing the part from the tool. This is the upper delamination shown in Figure 9.

2) A 5" x 18" area roughly rectangular in shape between the hull plies and the strake over-plies (between spray strake and boat side). This is the lower delamination shown in Figure 9.

Figure 9: Both delamination and stains from the tooling were observed.

- 1) Thin gel coat gave the appearance of several scratches.
- 2) A variety of discolorations that are typical of EB curing were also observed, particularly in the foam core. However, there is no apparent change in color for the cosmetically important gel coat finish.
- 3) Regions of radius formed by the tooling have epoxy on the gel coat surface as described on page 7 (see Figure 9).

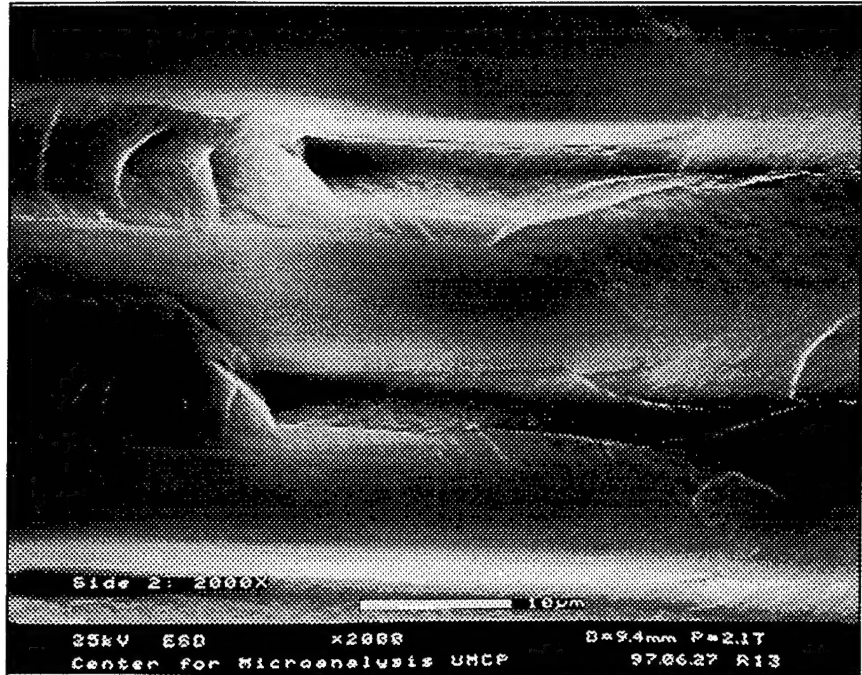
The cause of the delamination appeared to be a lack of proper wetting. Samples of fiber were removed for microscopic evaluation. Optical inspection was not more conclusive, so further magnification to 2000 X using a scanning electron microscope confirmed insufficient wetting in the region of delamination (Figure 10), while the sample from a region having no delamination exhibited complete coverage of the fibers with resin (Figure 11).

Figure 10: Fibers in region of delamination show lack of resin coverage.

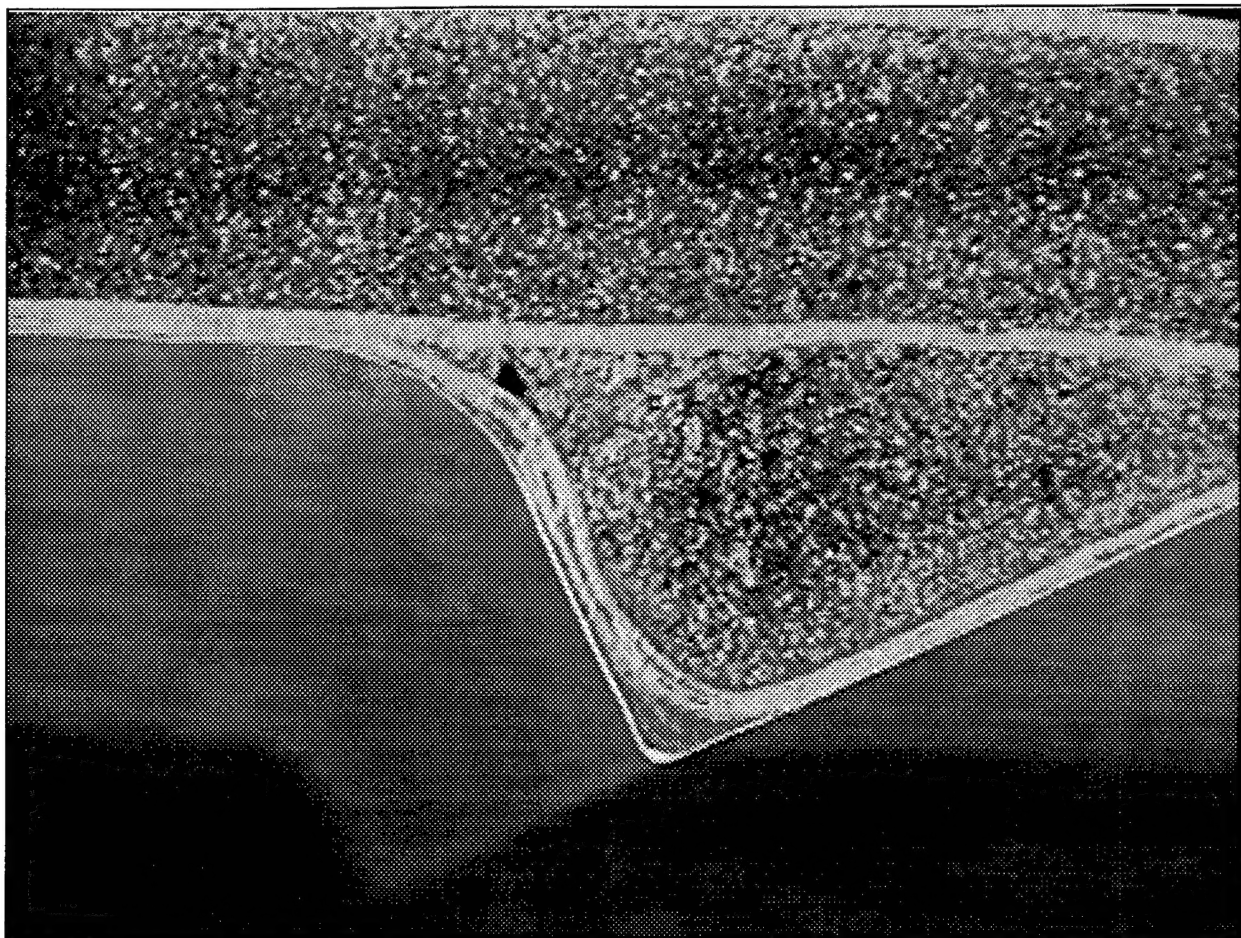
In addition to the regions of delamination, there are voids between the foam core and adjacent plies at the stake (see example in Figure 12) and longitudinal support. All regions with voids and delamination appear to be resin starved.

Figure 12: Void in the spray strake
